Village of Cleveland
Municipal Facilities Report

PRA Project #08012
27 January 2009

Village hall conditions

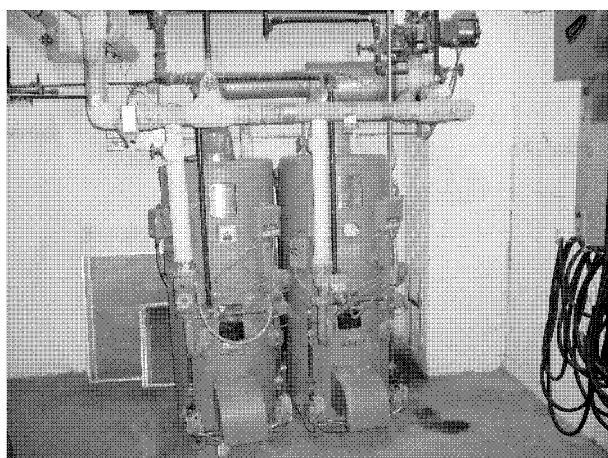
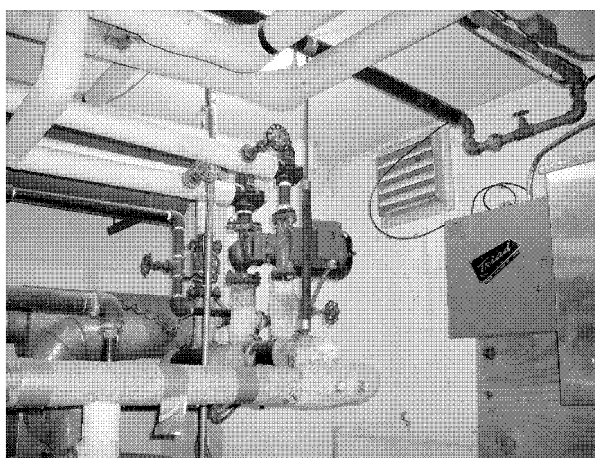
The building is served by a hot water boiler plant consisting of two Triad boilers located in the basement. Both boilers are each rated at 210,000 BTU input and are gas fired.

The boilers have gas burners firing at approximately 80% efficiency.

Building heat is maintained by perimeter wall mounted hot water radiation on the ground level and a hot water heating coil serving the lower level. The building zoning is controlled by three in-line pumps. The pumps are cycled as required to maintain temperature control.

Continue preventative maintenance on the system.

We recommend that as part of the proposed remodeling work, that the existing hot water radiation be replaced with new equipment. This would be for aesthetic purposes only as the current radiation is in proper working order.

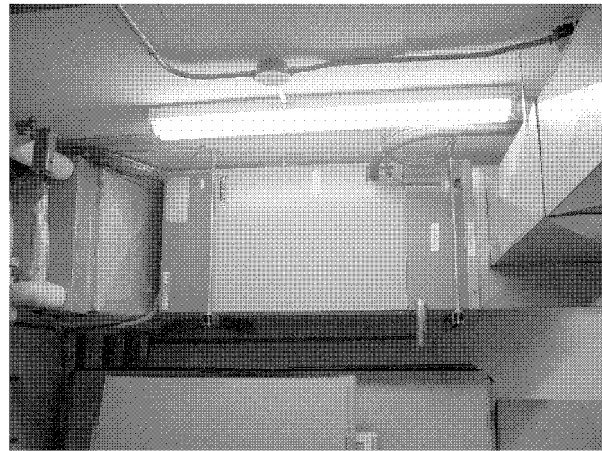
The lower level is served by one constant volume air handling unit. The system consists of a central supply fan which contains a DX cooling coil, fresh air and return air dampers with a hot water heating coil located within the supply ductwork. The associated condenser is located on the west exterior.

The lower level is served by a ducted exhaust using an exhaust fan located near the air handler.

If the lower level occupancy use changes, then we recommend replacing the central air conditioning equipment along with its associated ductwork, diffusers and control. The installation of a new central air conditioning unit with separate booster coils serving the different zones. This will increase the number of available temperature zones and provide a more modern temperature control system.

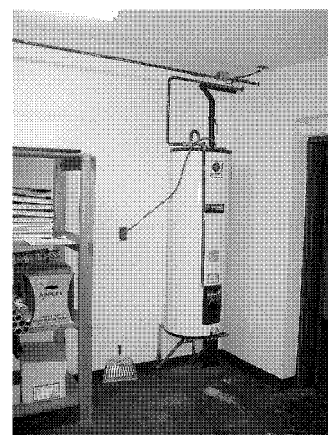
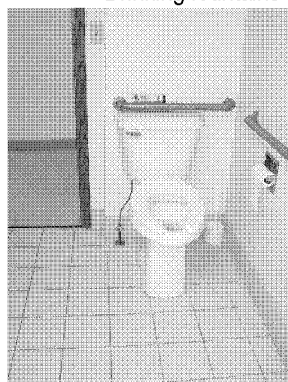
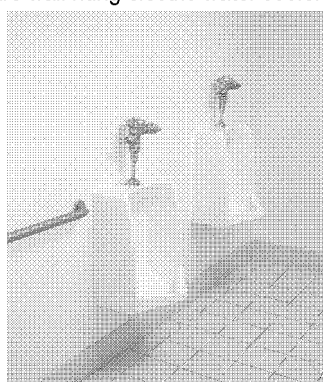
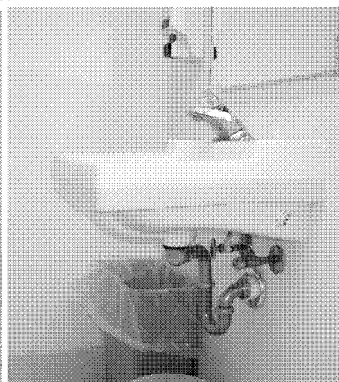
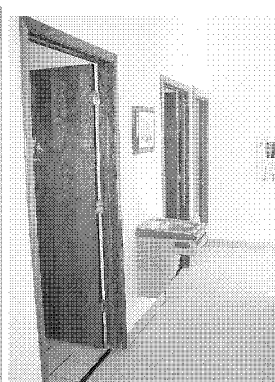
Lavatories are drop-in bowls with single handle faucets.

Drinking fountains are wall hung electric water coolers.

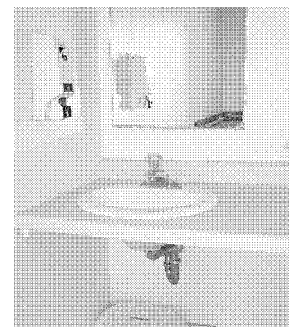
The lavatories do meet ADA Standards, however, the lavatory faucets do not meet ADA Standards.

All of the existing plumbing fixtures, except the lavatory faucets, do comply with the Water Conservation Standards and ADA ordinances. The lavatory faucets should be replaced.

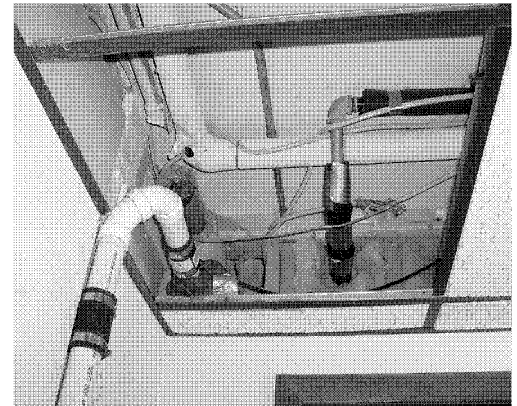
Most of the existing ductile iron sump pump discharge has been replaced with new PVC plastic pipe. Where the new PVC plastic pipe reconnects to the ductile iron pipe there appears to be a leak.

The existing ductile iron sump pump discharge piping should be replaced with new PVC plastic pipe to match what has been replaced. This should eliminate the leaking problem that is occurring.

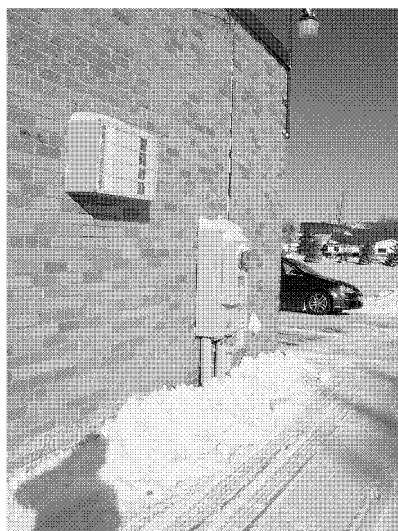
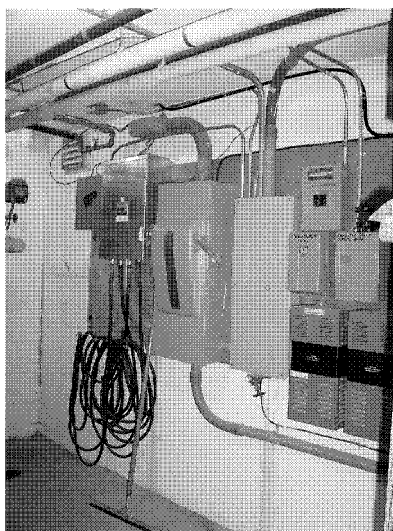
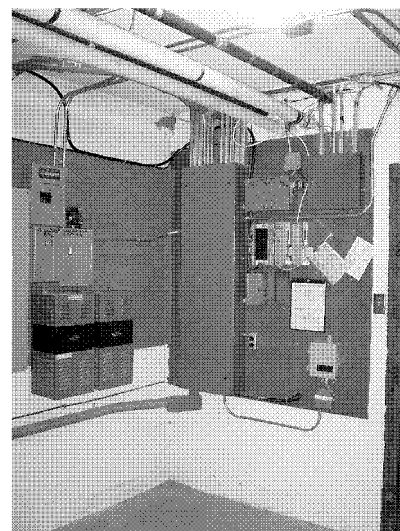
The electric service consisted of an exterior meter pedestal mounted on the east side of the facility. From this location a 400 amp single phase, 120/240 volt electric service entrance is terminated in a fusible disconnect enclosure in a basement boiler room. An automatic transfer switch was installed next to the disconnect switch to allow a remote generator connection and manual switchover upon power loss.

The disconnect switch feeds multiple panelboards in the basement. There are three newer style load centers which feed miscellaneous equipment and a 225 amp old-style ITE panelboard on the east wall.

If any building upgrades or expansion is provided to this facility, we would recommend removing all existing distribution equipment and providing a new main circuit breaker and new panelboard to replace the existing ITE panel on the east wall.

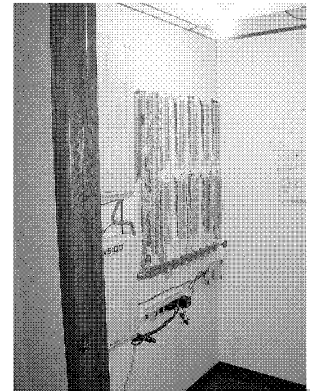
The facility contains a Panasonic phone system with Panasonic phones. All cabling is routed to a punchdown panel in the basement. Phone system appears to be operating correctly, however we would like input from the owner as to the condition of the existing phone system. All phone cabling appears to be category 3 type routed above ceilings and flush in walls.

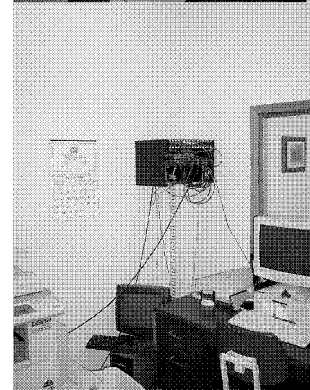
Data cabling has been added after the original construction of the building to various office locations. All data cabling was pulled above the lower floor lay-in ceiling to a data distribution punchdown located on the first floor. Data cabling is category 5 type and jacks appear to be category 5 type. Data cabling was not supported above lay-in ceilings.
