HIKA BAY HARBOR OF REFUGE

PRELIMINARY COASTAL ANALYSIS

PREPARED BY
FRESHWATER ENGINEERING

March 2018

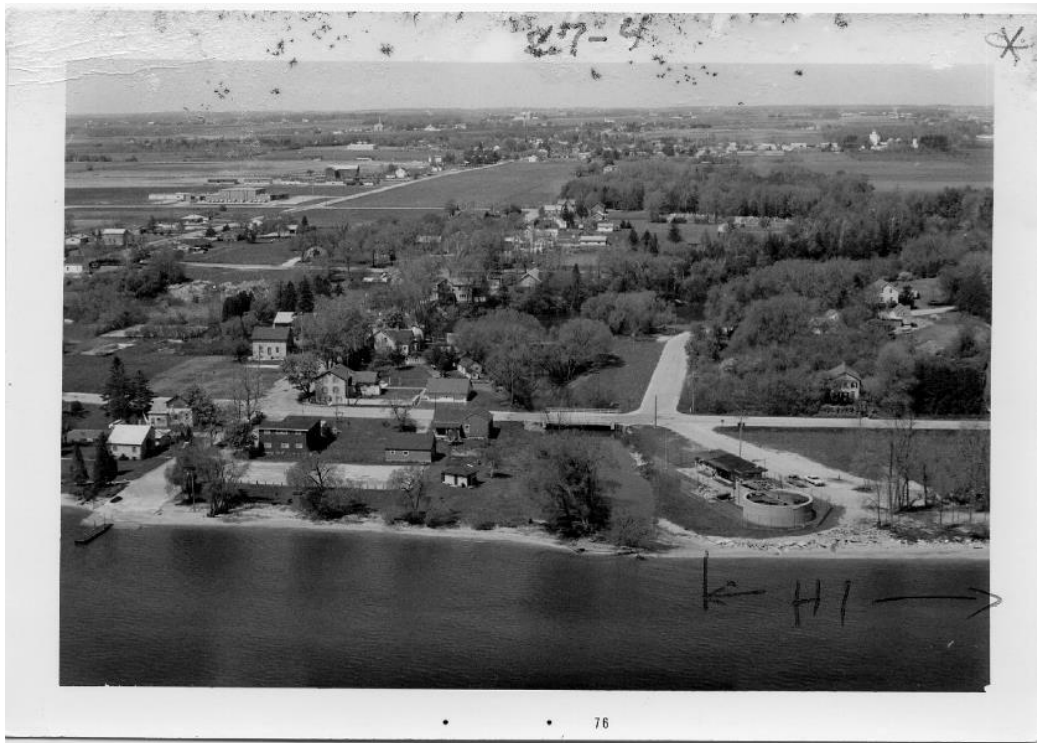
Figure 2. 1976 oblique aerial photo of the project site.

Generally, the site has not shown significant change since 1976. The beach widens to the north of the boat launch to Centerville Creek. Photos taken during periods of high water levels (1976, 2017) show much narrower beaches and a wider mouth. During lower water level years (2007, 2012), beaches are relatively wide and the mouth of Centerville Creek is narrower.

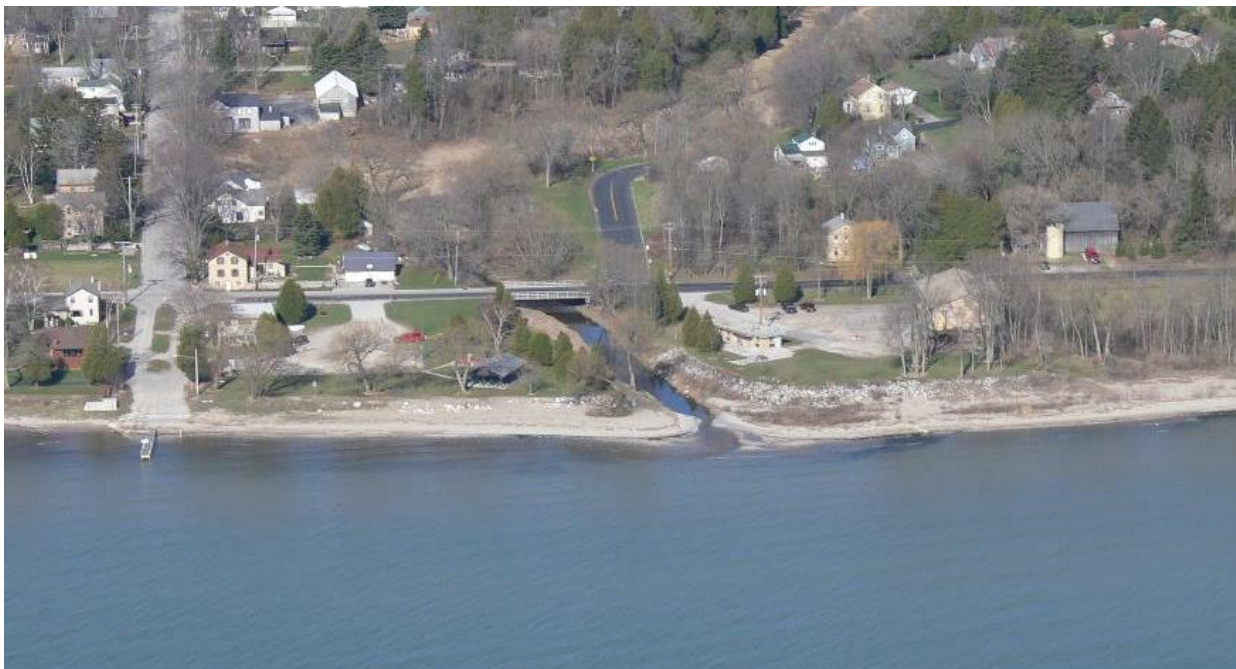
Figure 3. 2007 oblique aerial photo of the project site.

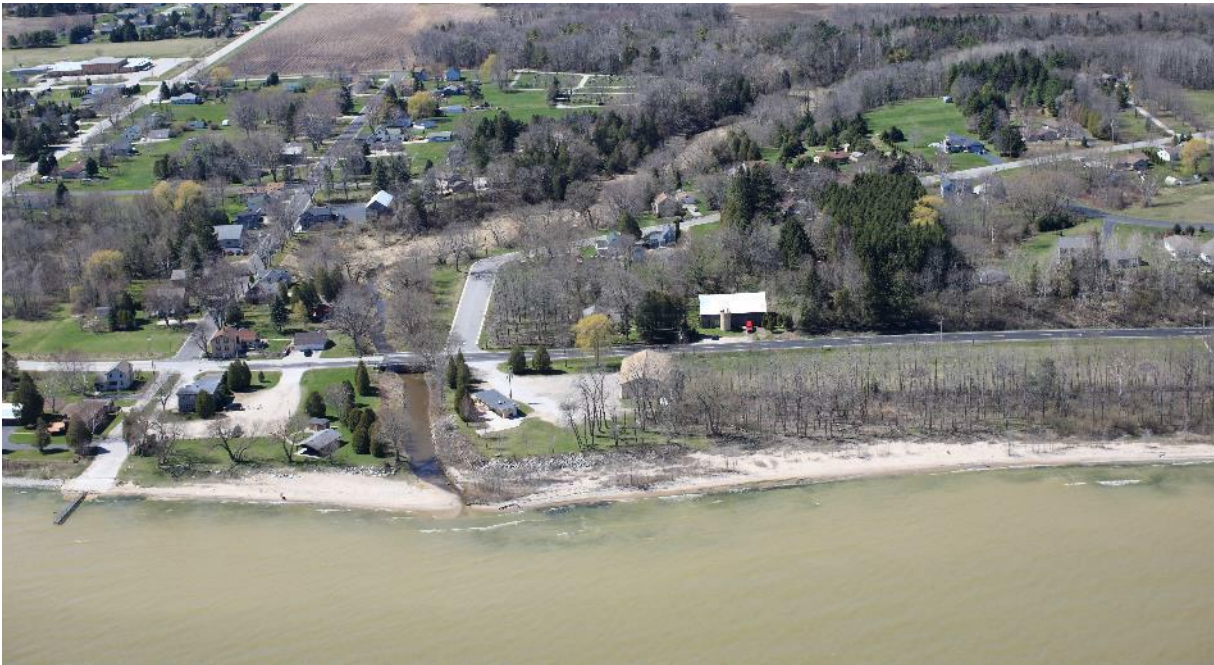
Figure 4. 2012 oblique aerial photo of the project site.

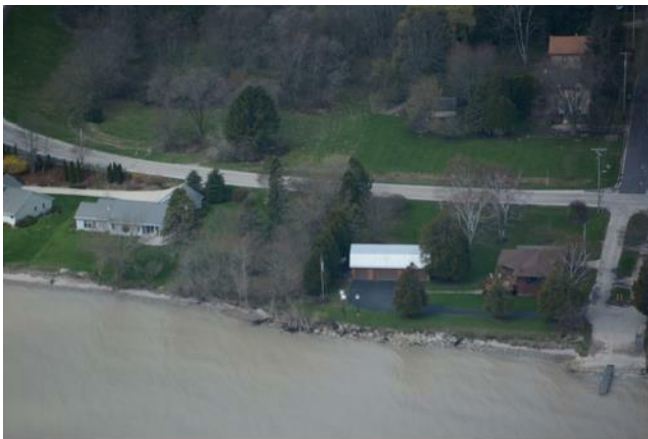
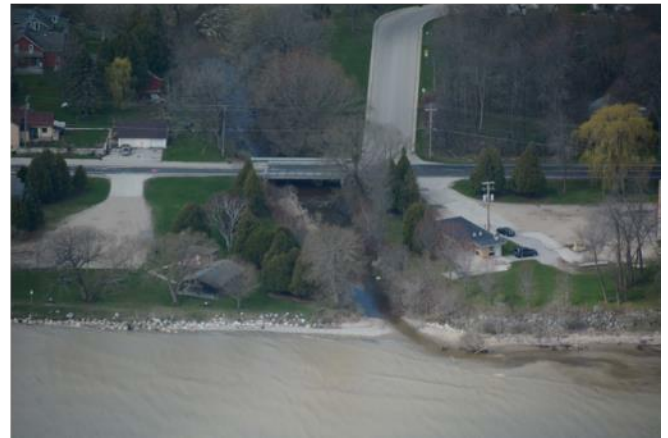
Figure 5. 2017 oblique aerial photo of the project site, split between two photos. There is no photo coverage immediately north of the boat launch.

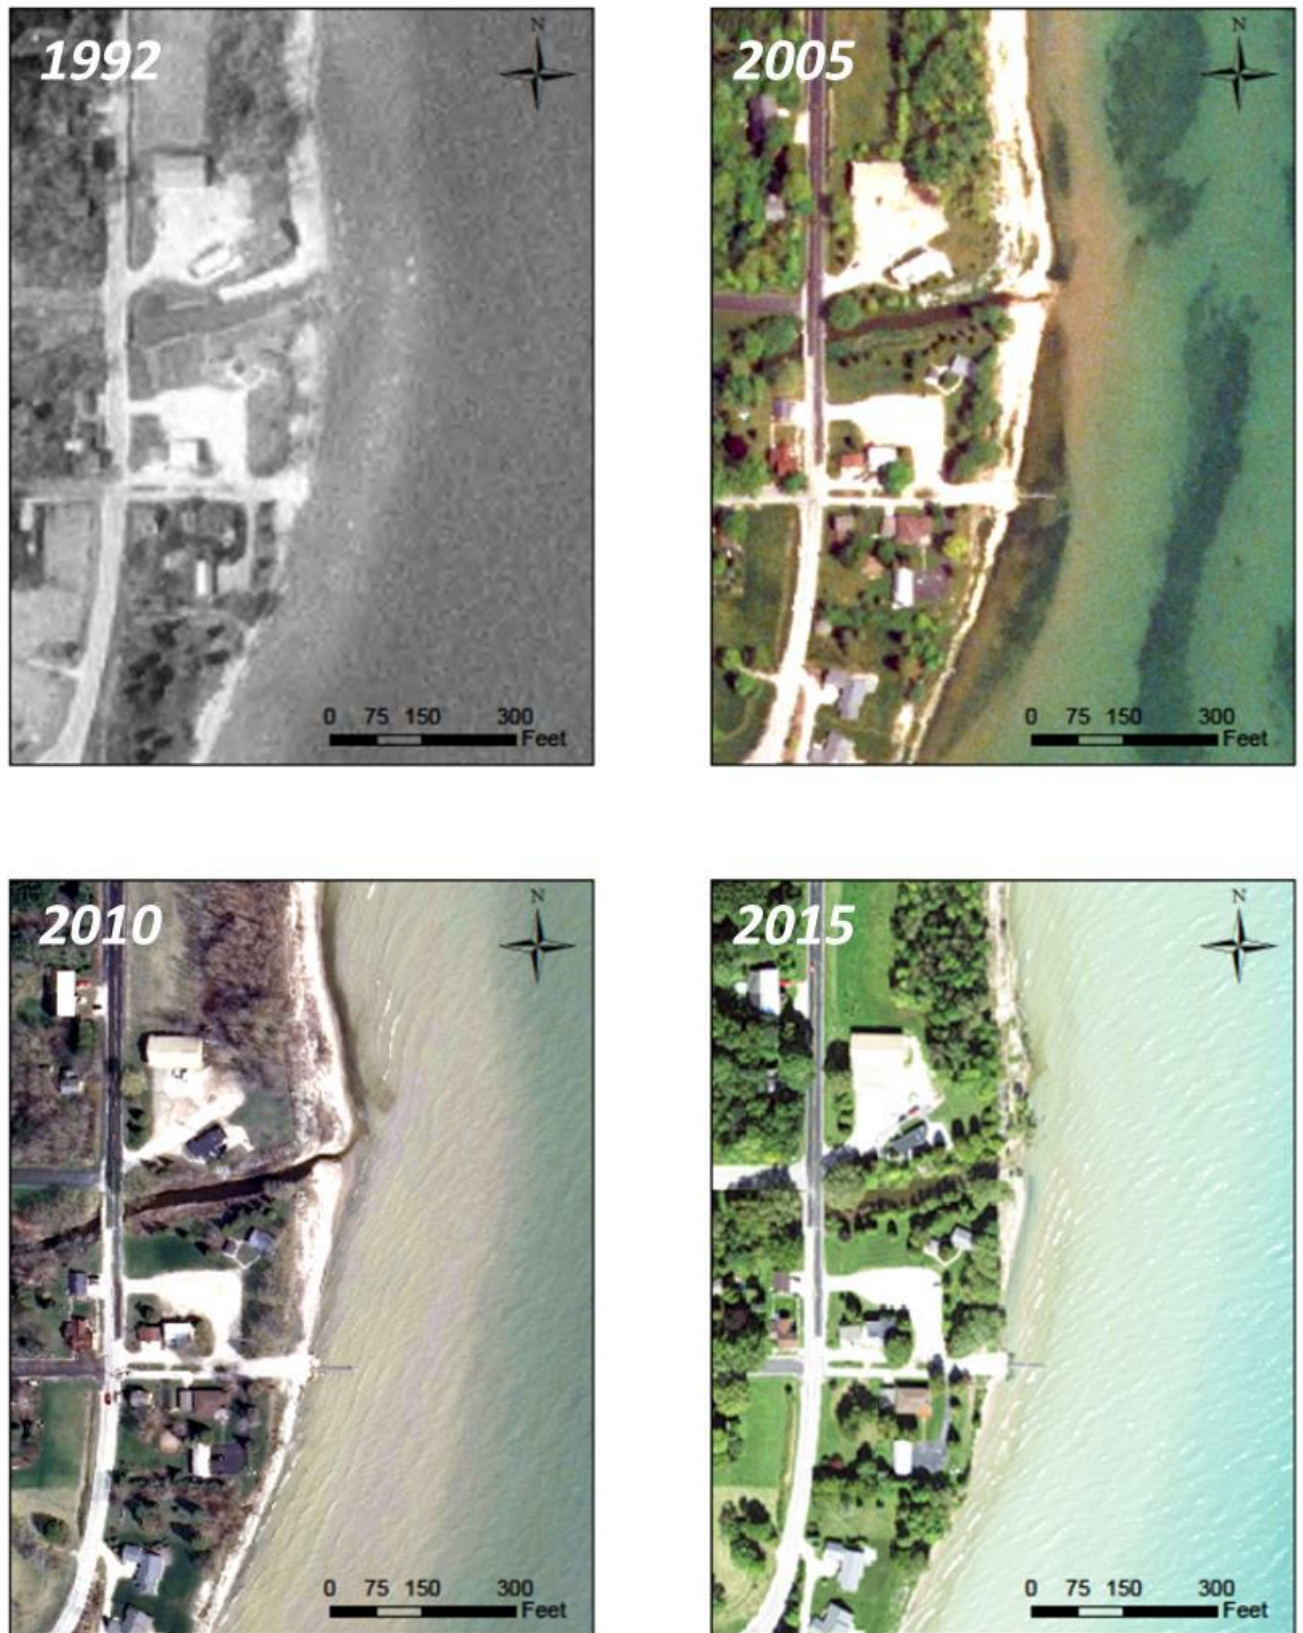
Figure 8. Orthophotos used for analysis of recent shoreline change.

Photos of the shoreline in the project area show that, in general, changes to the shoreline have been minor between 1992 and 2015 (Figure 8). A relatively wide beach is present north and immediately south of Centerville Creek in all photos, though the beach is submerged in 2015 due to the higher water levels. South of the boat launch, beaches are narrow and not present in 2015. Low water levels that persisted from 2000-2014 explain why beaches appear wider in the 2005 and 2010 photos. A sharp rise in water level after 2014 explains the apparent shoreline retreat in 2015.

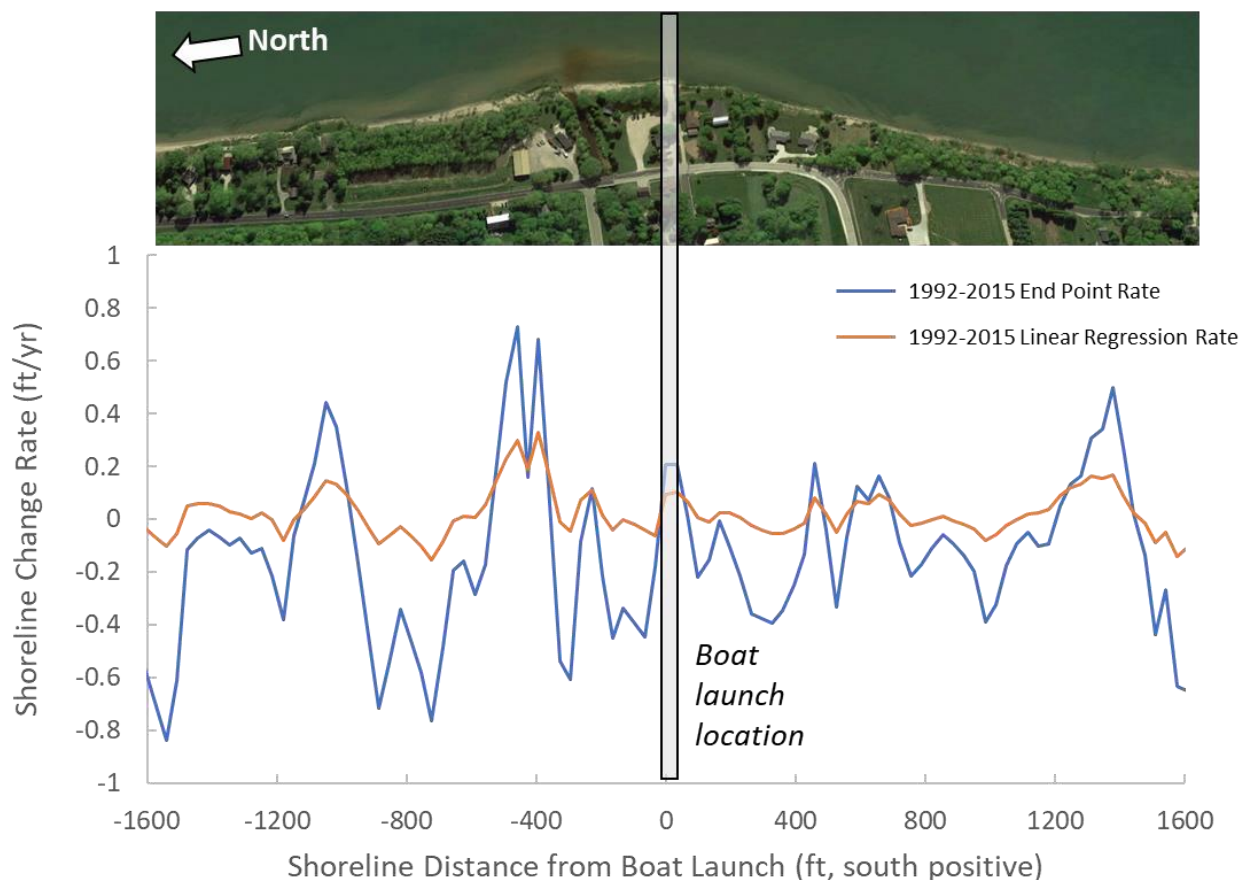
Figure 10. Comparison of EPR and LRR methods of shoreline change measurement in the area surrounding the project site.

Shoreline change in the reach extending 500 meters to the north and south of the boat launch is highly dependent on the local shoreline characteristics. To the north of the launch and in Hika Bay Park, shoreline position on the wide sandy beaches is highly sensitive to water level fluctuations, as evidenced by the -3.86 ft/year retreat rate between 2010 and 2015 (Table 3). South of the launch shoreline position is less sensitive to water level changes, suggesting a steeper foreshore slope where a low bluff is present. The linear regression rate for the reach is 0.02 feet/year between 1992 and 2015, indicating that the shoreline is stable, neither eroding nor accreting between periods of high water (Figure 10).
